AIR SERVICE INFORMATION CIRCULAR

August 15, 1922

STATIC TEST OF THOMAS-MORSE MB-6 AIRPLANE

Prepared by E. R. Weaver
Engineering Division, Air Service
McCook Field, Dayton, Ohio
May 2, 1922

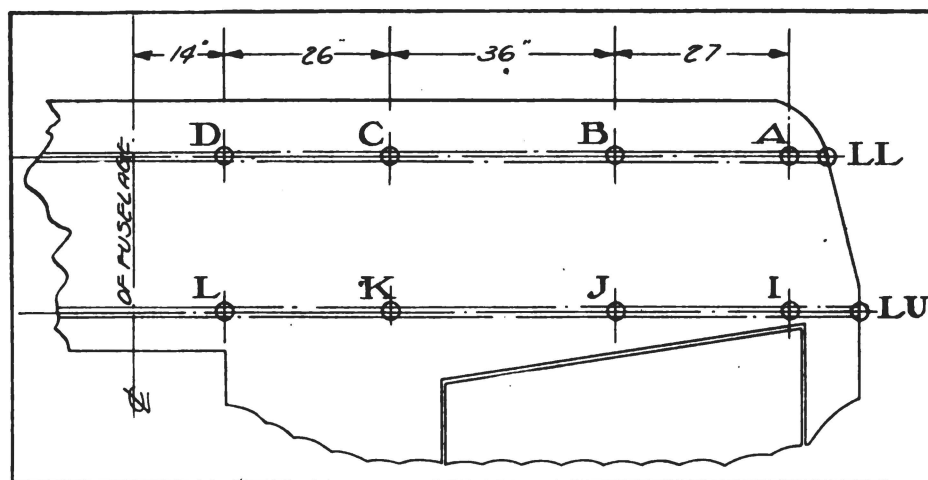
FIG. 7.—Deflection chart at low incidence.

The wings supported a load factor of 5.5 without signs of failure.

The deflections are tabulated in Figure 7.

TABLE OF DEFLECTIONS FOR LOW INCIDENCE TEST.

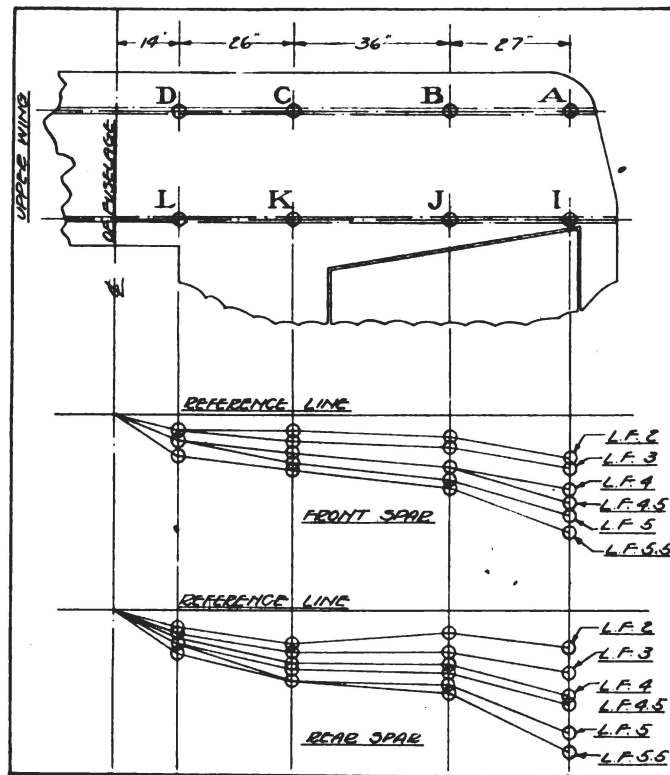
FIG. 8.—Spar deflection curves at low incidence.

Figure 8 shows the spar deflection curves.

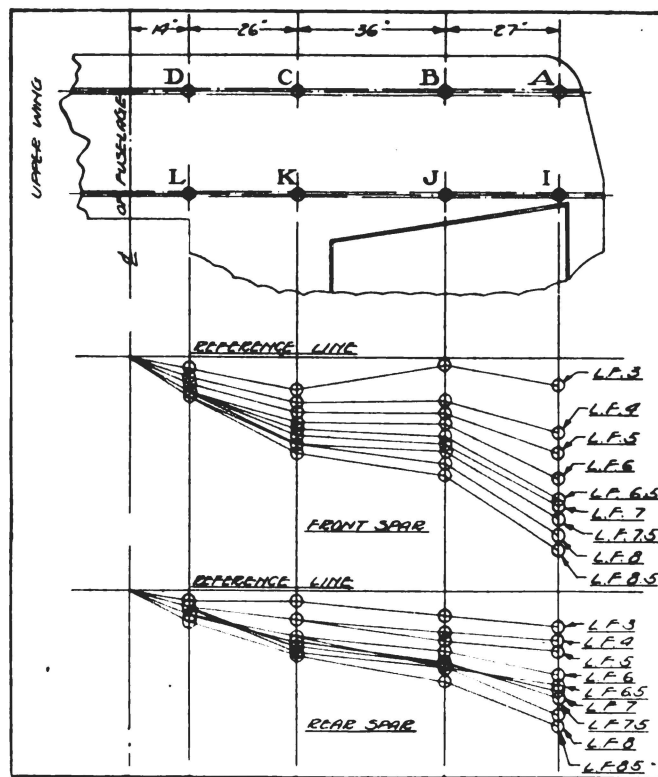
FIG. 11.—Spar deflection curves at high incidence.

The required load factor for the high-incidence test was 8.5. The wings supported this load satisfactorily. At a load factor of 9 the left rear strut failed in compression when the strut fitting bolt sheared.

Figure 11 shows the spar deflection curves.

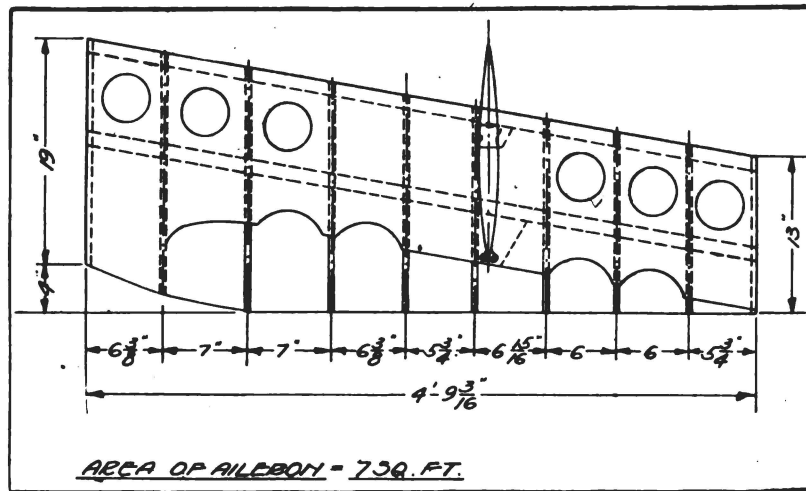
FIG. 12.—Aileron drawing and loading schedule.

The aileron supported an average load of 37.5 pounds per square foot without failure.

Load in pounds, square feet.	Pull on stick.	Total load on aileron.	Remarks.
	<i>Pounds.</i>	<i>Pounds.</i>	
5	15	35	
10	20	70	
15	25	105	
20	35	140	
22.5	45	157.5	
25	55	175.0	
27.5	60	192.5	
30	65	210.0	
32.5	70	227.5	
35	80	245.0	
37.5	85	262.5	Held load without failure.

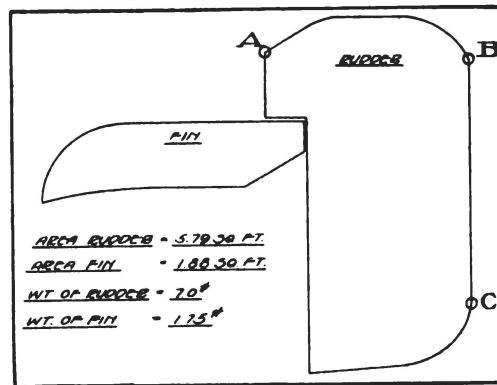
FIG. 18.—Loading schedule and results of test of rudder and fin.

The required loading for the rudder and fin was 30 pounds per square foot. The surfaces supported an average loading of 40 pounds per square foot without signs of failure.

Rudder control wires interfered with diagonal fuselage bracing wires.

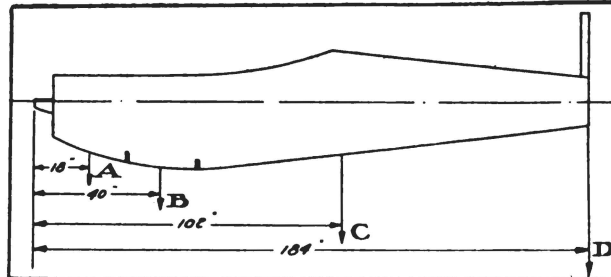
FIG. 21.—Deflections and results of fuselage test.

The fuselage structure was required to support a load factor of 7. The engine bearers supported a load factor of 7.5 without any signs of failure. With load factor of 11 on the tail the wires in the fourth bay to the rear of the pilot's cockpit failed.

The longerons showed much distortion and small cracks, developed in them. After the load was removed the longerons showed a permanent set.

Load factor.	Deflections, in inches, at—				Remarks.
	A	B	C	D	
2	0.6	0.4	0.1	-1.0	
3	.8	.8	.3	0	
4	1.0	.9	.3	0	
5	1.2	1.0	.4	-.1	
5.5	1.2	1.1	.4	-1.0	
6	1.2	1.2	.6	-.6	
6.5	1.2	1.2	.7	-.6	
7	1.3	1.3	.7	-.6	
7.5	1.4		.7	-.6	
8	1.4		.7	-.4	
8.5				-.3	
9				+.1	
9.5				.4	
10				.9	
10.5				1.5	
11				1.8	Held.
11.5					Failure of right and left brace wires in second bay forward from stern post.

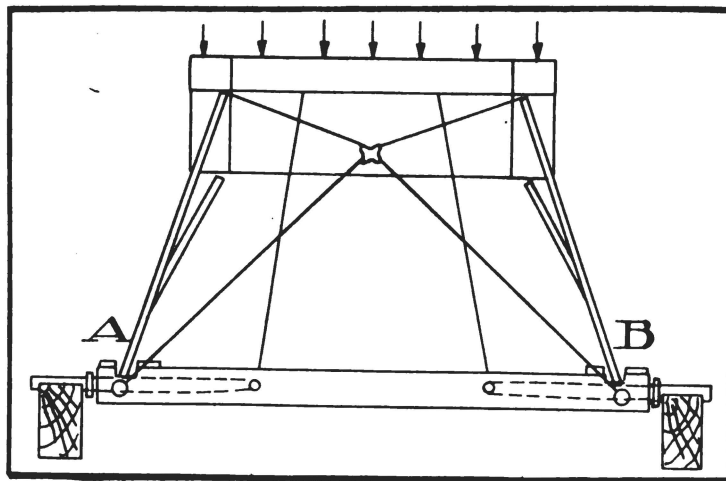
FIG. 23.—Loading schedule and results of test of landing chassis.

The required load factor for the landing chassis was 6. The chassis supported this load without signs of failure. At a load factor of 8 the right front strut failed.

Load factor.	Deflections, inches, at—		Total load (pounds).	Remarks.
	A	B		
2	$\frac{1}{4}$	$\frac{1}{4}$	4,046	
3	$\frac{1}{4}$	$\frac{1}{4}$	6,069	
4	$\frac{1}{4}$	$\frac{1}{4}$	8,092	
4.5	$\frac{1}{4}$	$\frac{1}{4}$	9,103.5	
5	$\frac{1}{4}$	1.0	10,115.0	
5.5	$\frac{1}{4}$	$1\frac{1}{4}$	11,126.5	
6	$\frac{1}{4}$	$1\frac{1}{4}$	12,138.0	
6.5	$\frac{1}{4}$	$1\frac{1}{4}$	13,149.5	
7	$\frac{1}{4}$	$1\frac{1}{4}$	14,161.0	
7.5	$\frac{1}{4}$	$1\frac{1}{4}$	15,172.5	
8	$\frac{1}{4}$	$1\frac{1}{4}$	16,184.0	Failure of right front strut.

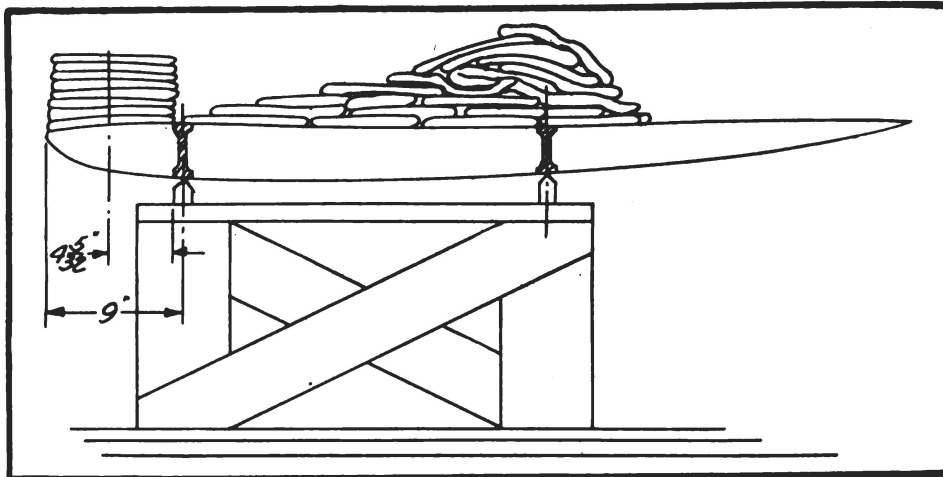
At a load of 3,300 pounds the cap strips failed and the leading edge portion broke off at the rear side of the front spar. This tore the front spar from the rest of the wing structure.

The leading edge of the MB-6 wing is very satisfactory structurally since the factor of failure was 20.8, the required load factor for this test being 14.

Load on MB-6 wings for factor of 1 = 1,807 pounds.
 Load on upper wing for factor of 1 = $1,807 \times .52 = 939.64$ pounds.
 Span over which wing was loaded = 17.783 feet.
 Load on upper wing per foot run = $\frac{939.64}{17.783} = 52.83$ pounds.
 Load for factor of 1 on leading edge = $\frac{52.83}{2} = 26.465$ pounds.
 Load on leading edge causing failure = 3,300 pounds.
 $\frac{3,300}{6} = 550$ pounds = load per foot run causing failure.
 $\frac{550}{26.465} = 20.8$ = factor at which leading edge failed.
